Bateman Island Causeway Conceptual Design

Mid-Columbia Fisheries Enhancement Group • Benton Conservation District
Gray and Osborne • Northwest Hydraulic Consultants

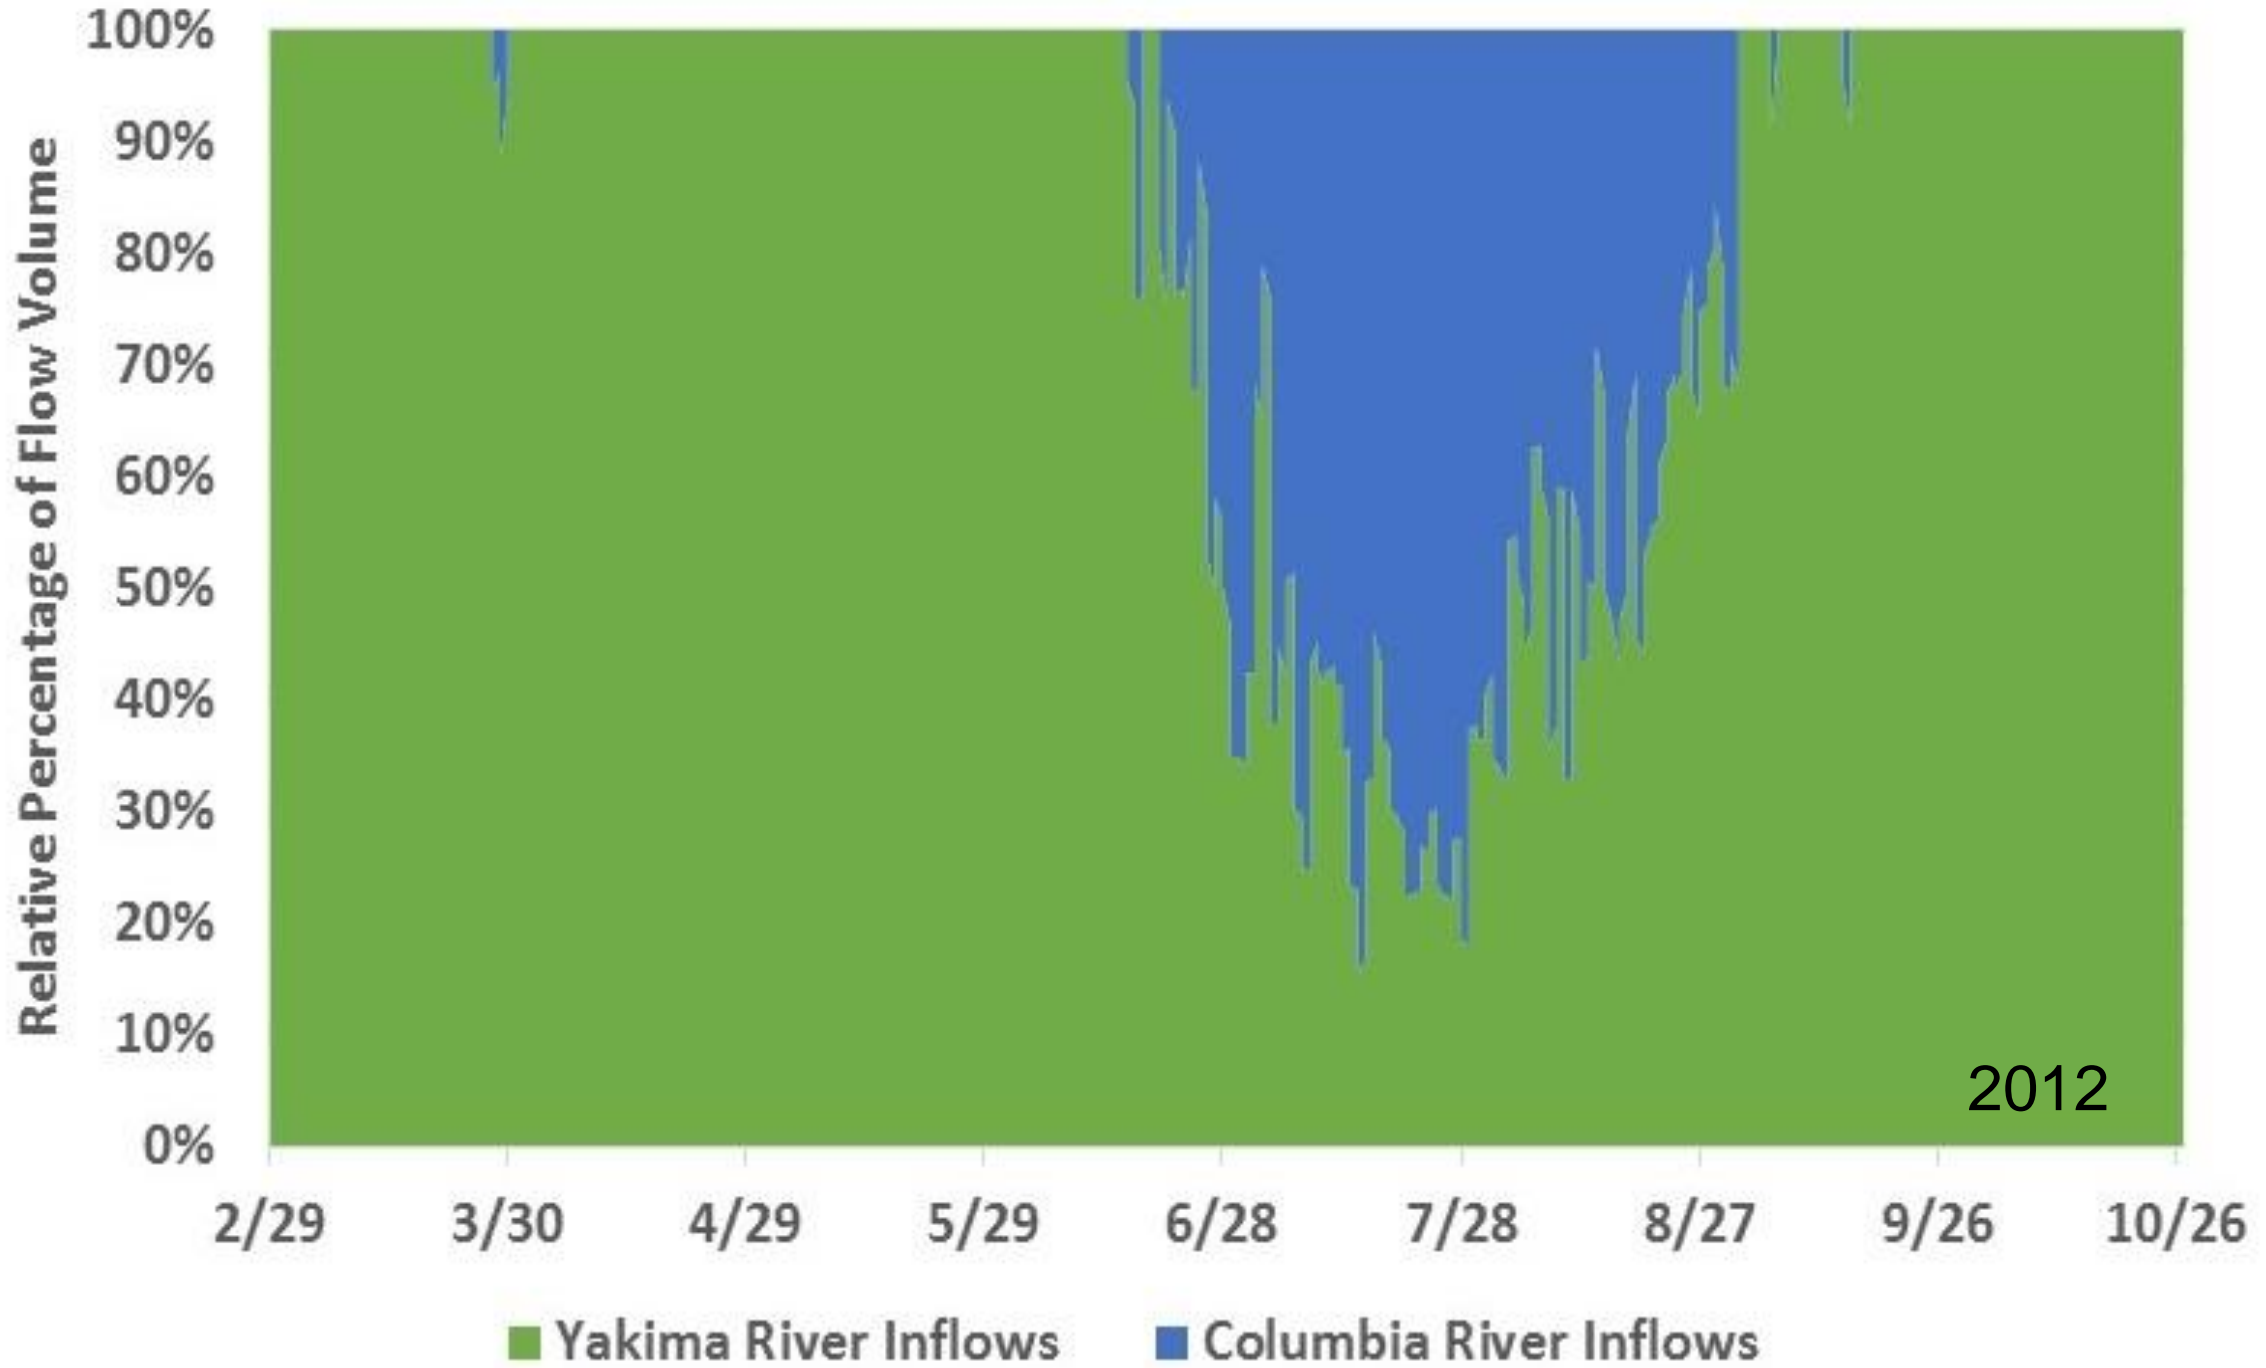
Alternative 8, June 1, 2012

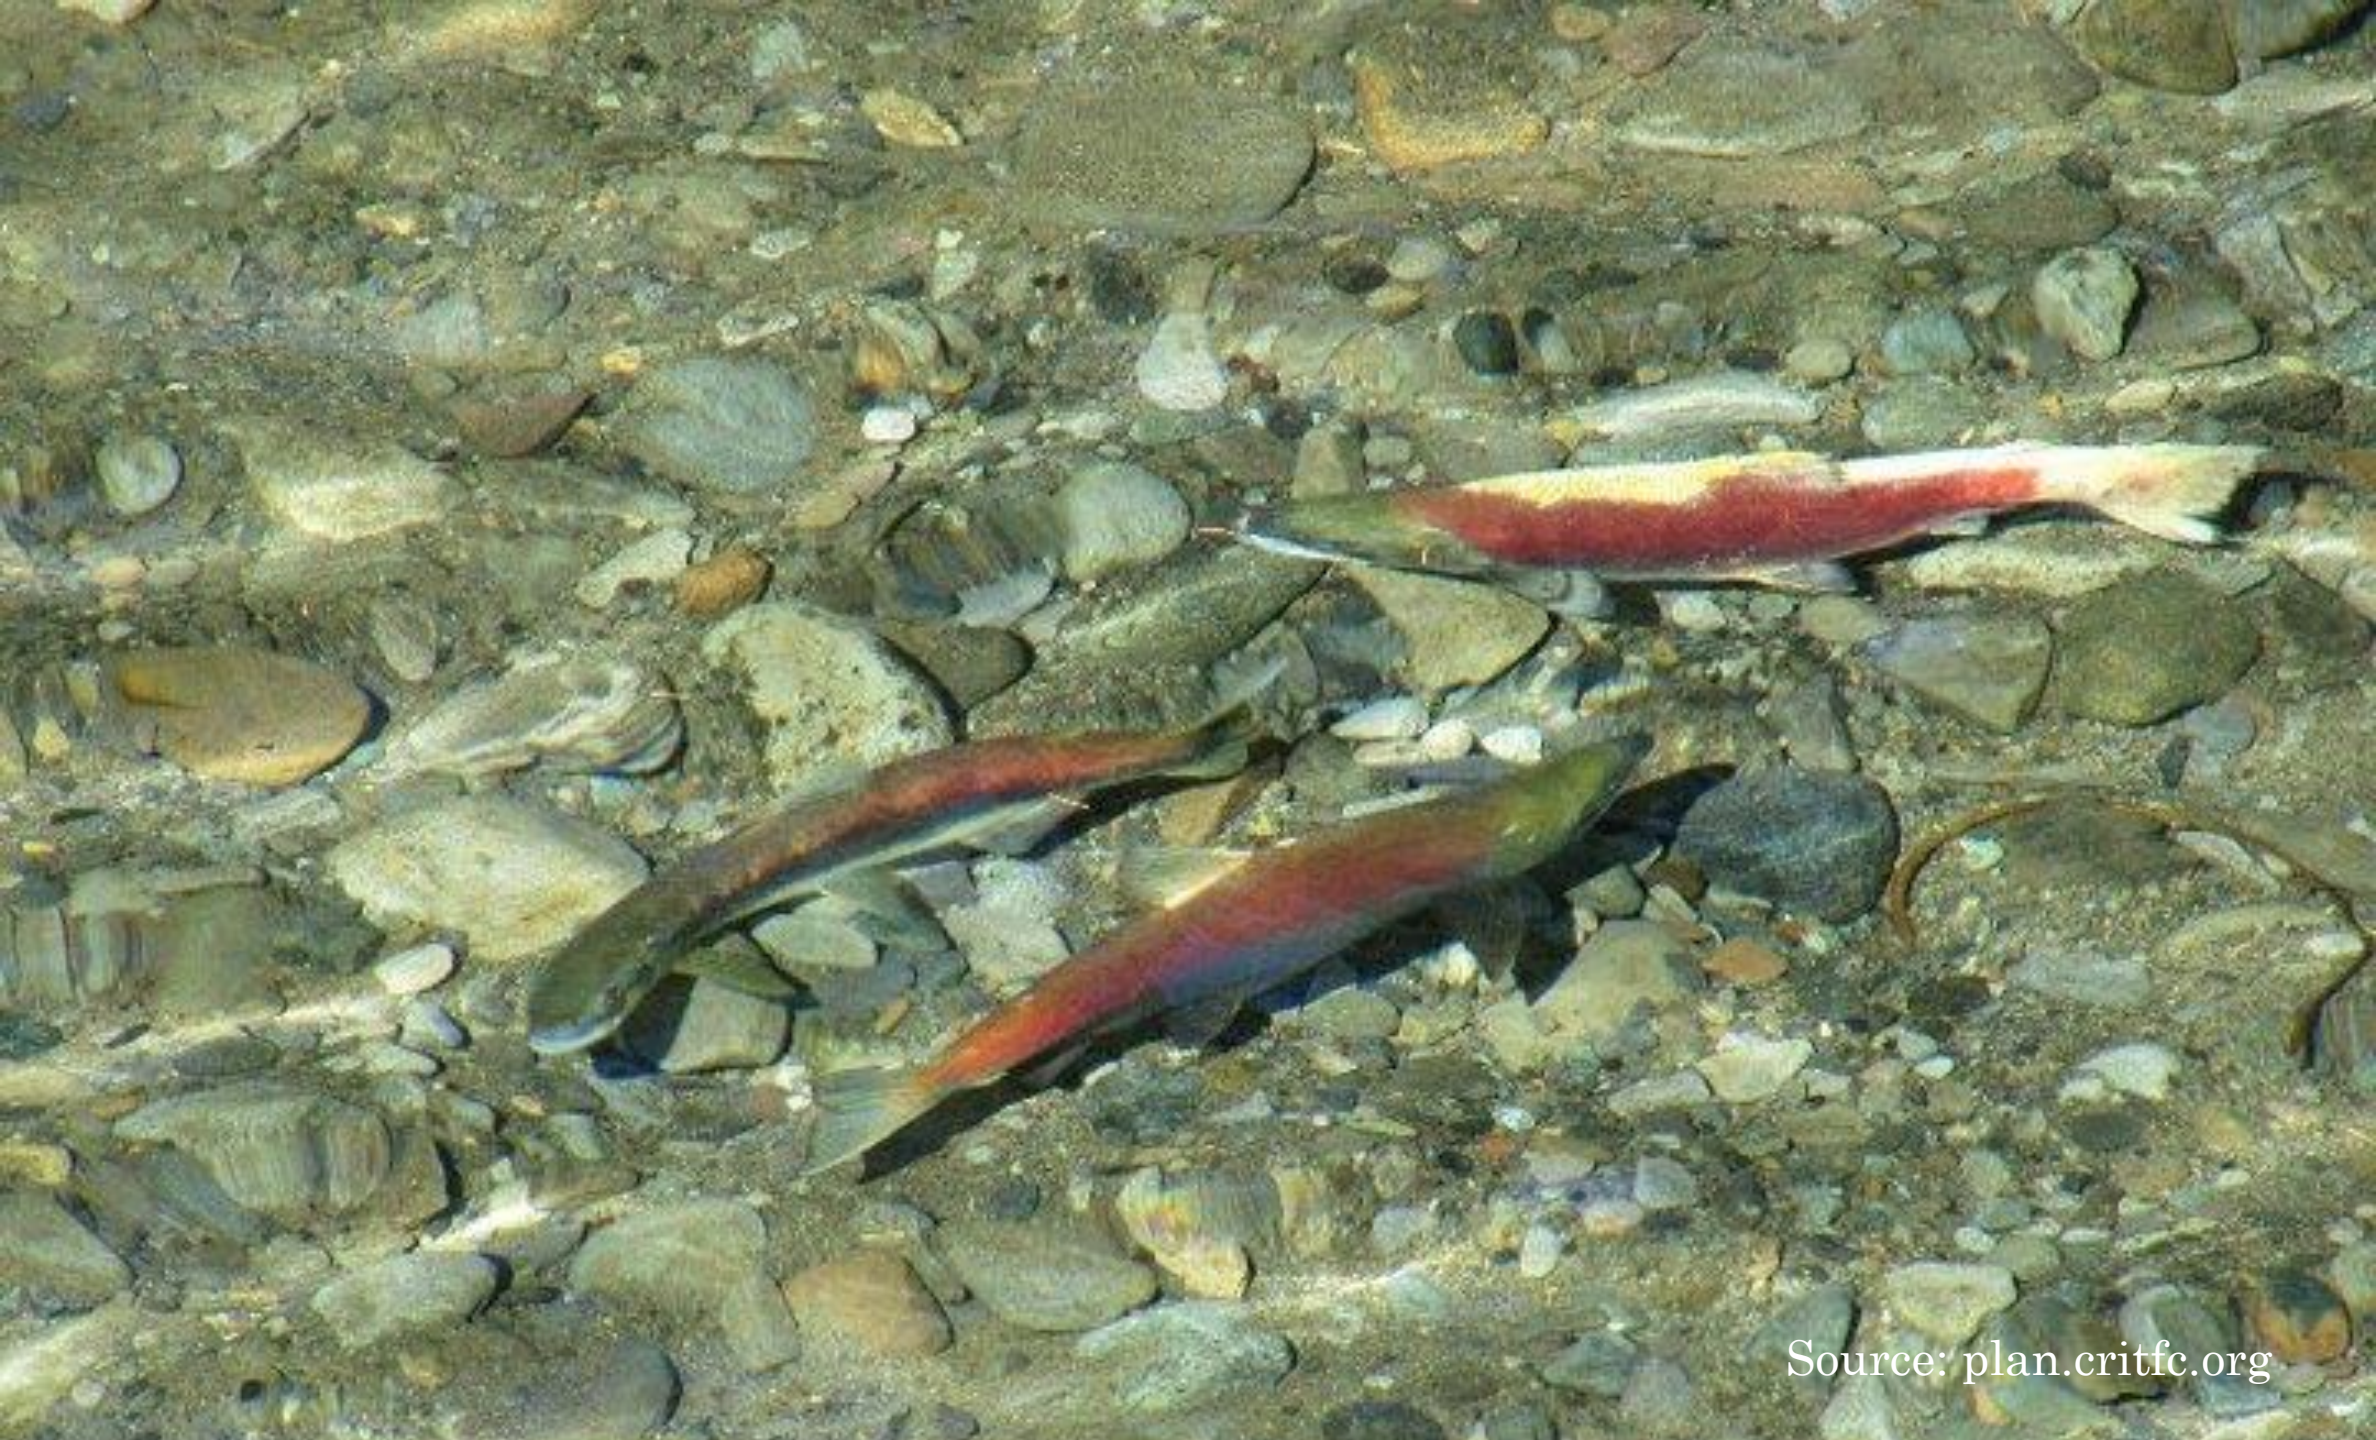
Number of summer days when downstream temperature > upstream

Alternative	Measured just above confluence			Measured in reopened causeway channel	
	2012	2014		2012	2014
Alt. 1 - Existing Conditions	38	38		N/A	N/A
Alt. 6 - 130 foot Breach	28	36		54	34
Alt. 7 - 200 foot Breach	30	35		46	32
Alt. 5 - 260 foot Breach	18	26		31	26
Alt. 3 - 560 foot Full Breach	14	24		28	25
Alt. 8 – 560 foot Breach + Breakwater	16	28		32	25

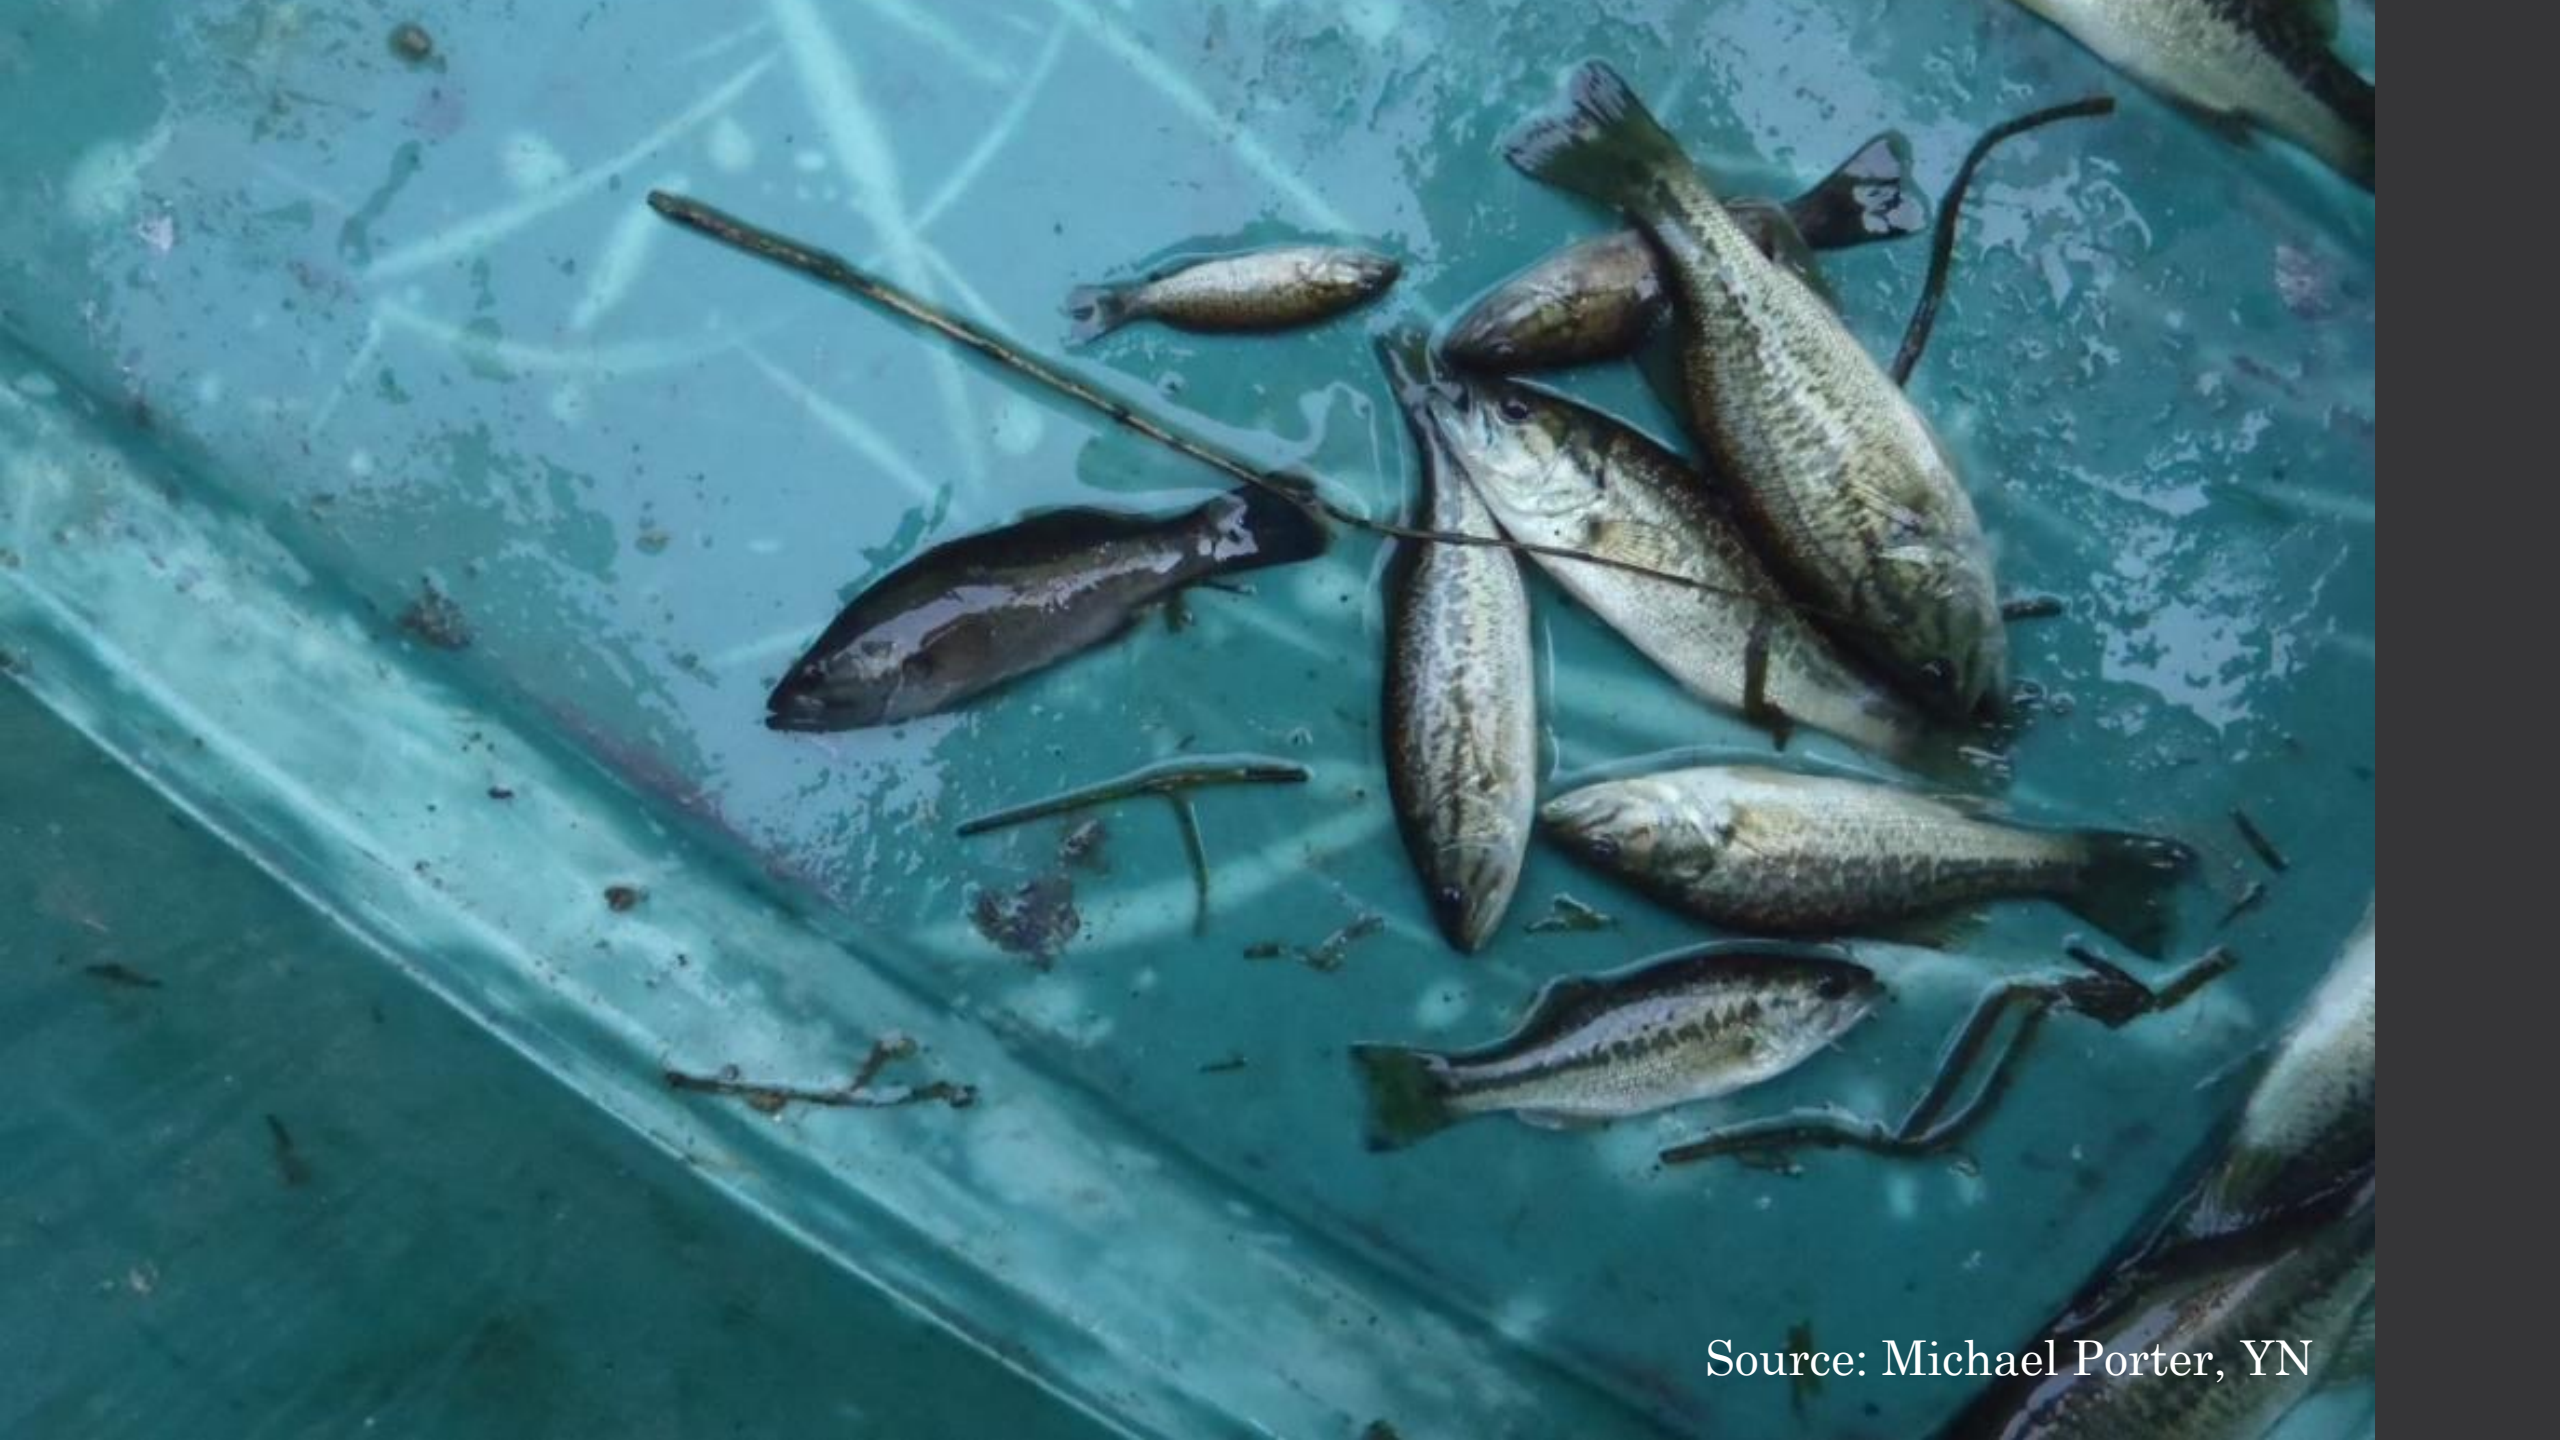
Maximum Spring (March 15 – May 31) 7-DADMax Temperature

Alternative	Measured in channel west of island	
	2012	2014
Alt. 1 - Existing Conditions	19.6 °C	21.1 °C
Alt. 6 - 130 foot Breach	17.7 °C	18.7 °C
Alt. 7 - 200 foot Breach	17.6 °C	18.6 °C
Alt. 5 - 260 foot Breach	17.6 °C	18.5 °C
Alt. 3 - 560 foot Full Breach	17.6 °C	18.5 °C
Alt. 8 – 560 foot Breach + Breakwater	17.6 °C	18.5 °C

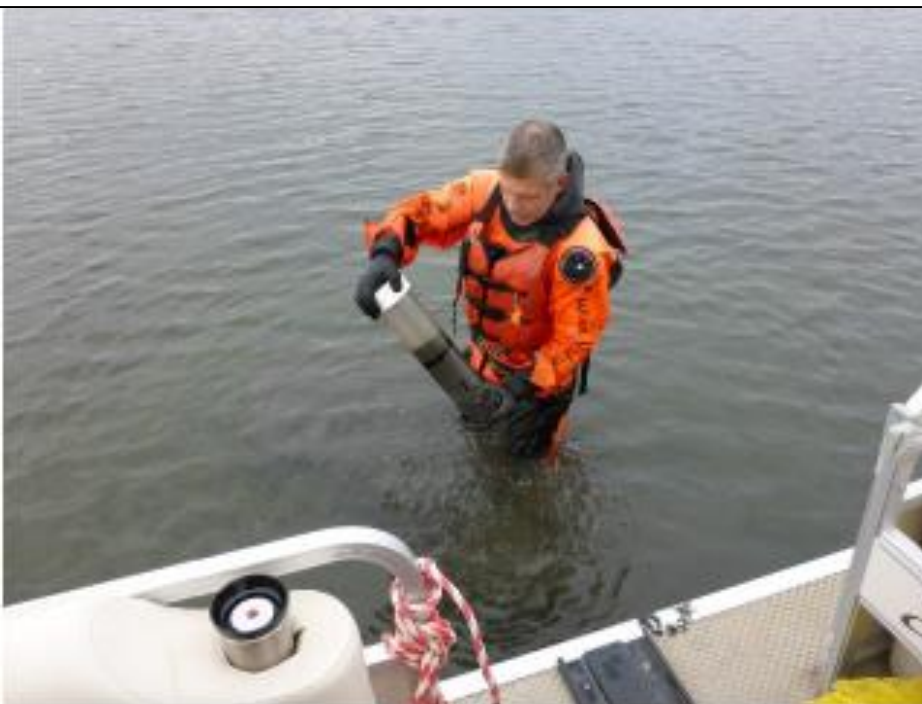
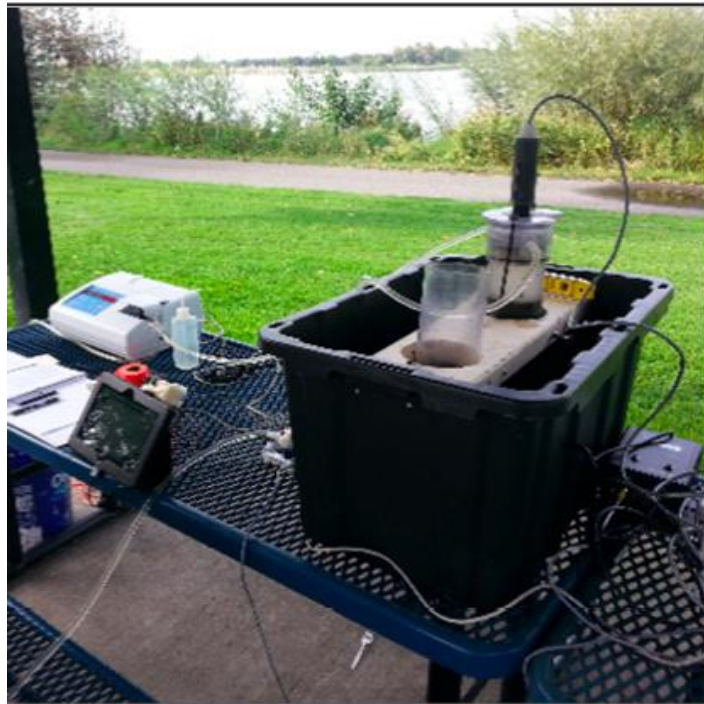
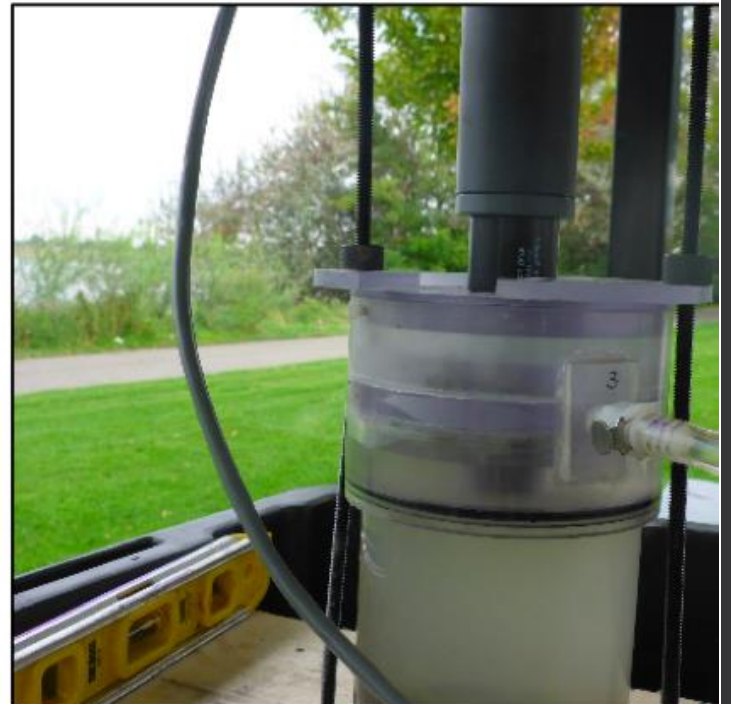
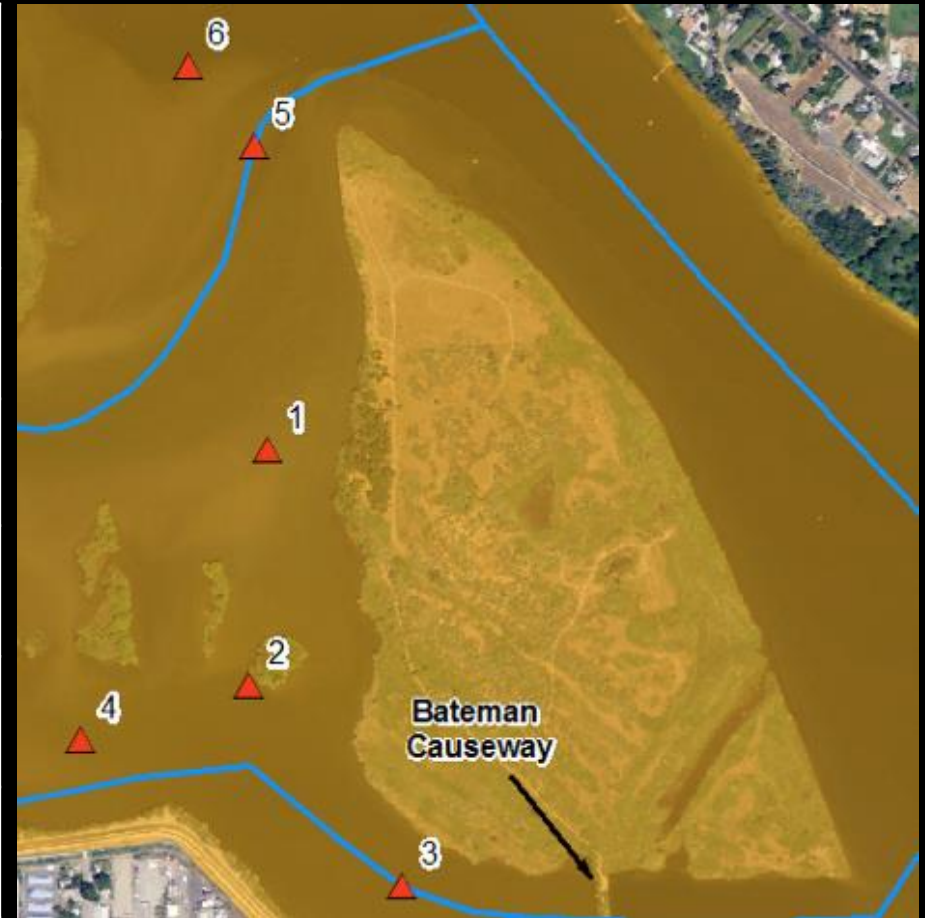
Sediment

Time required for full erosion at each area after full breach

Area	Low Flow	Mid Flow	High Flow
	weeks	weeks	weeks
Area 6: North of Yakima Inflow	11.9	0.7	0.2
Area 5: Yakima River	no movement	1.1	0.3
Area 1: West Side of Island	112	6.2	1.8
Area 4: Small Channel South	no movement	184.7	10.2
Area 3: West of Causeway	57.9	3.5	1.0

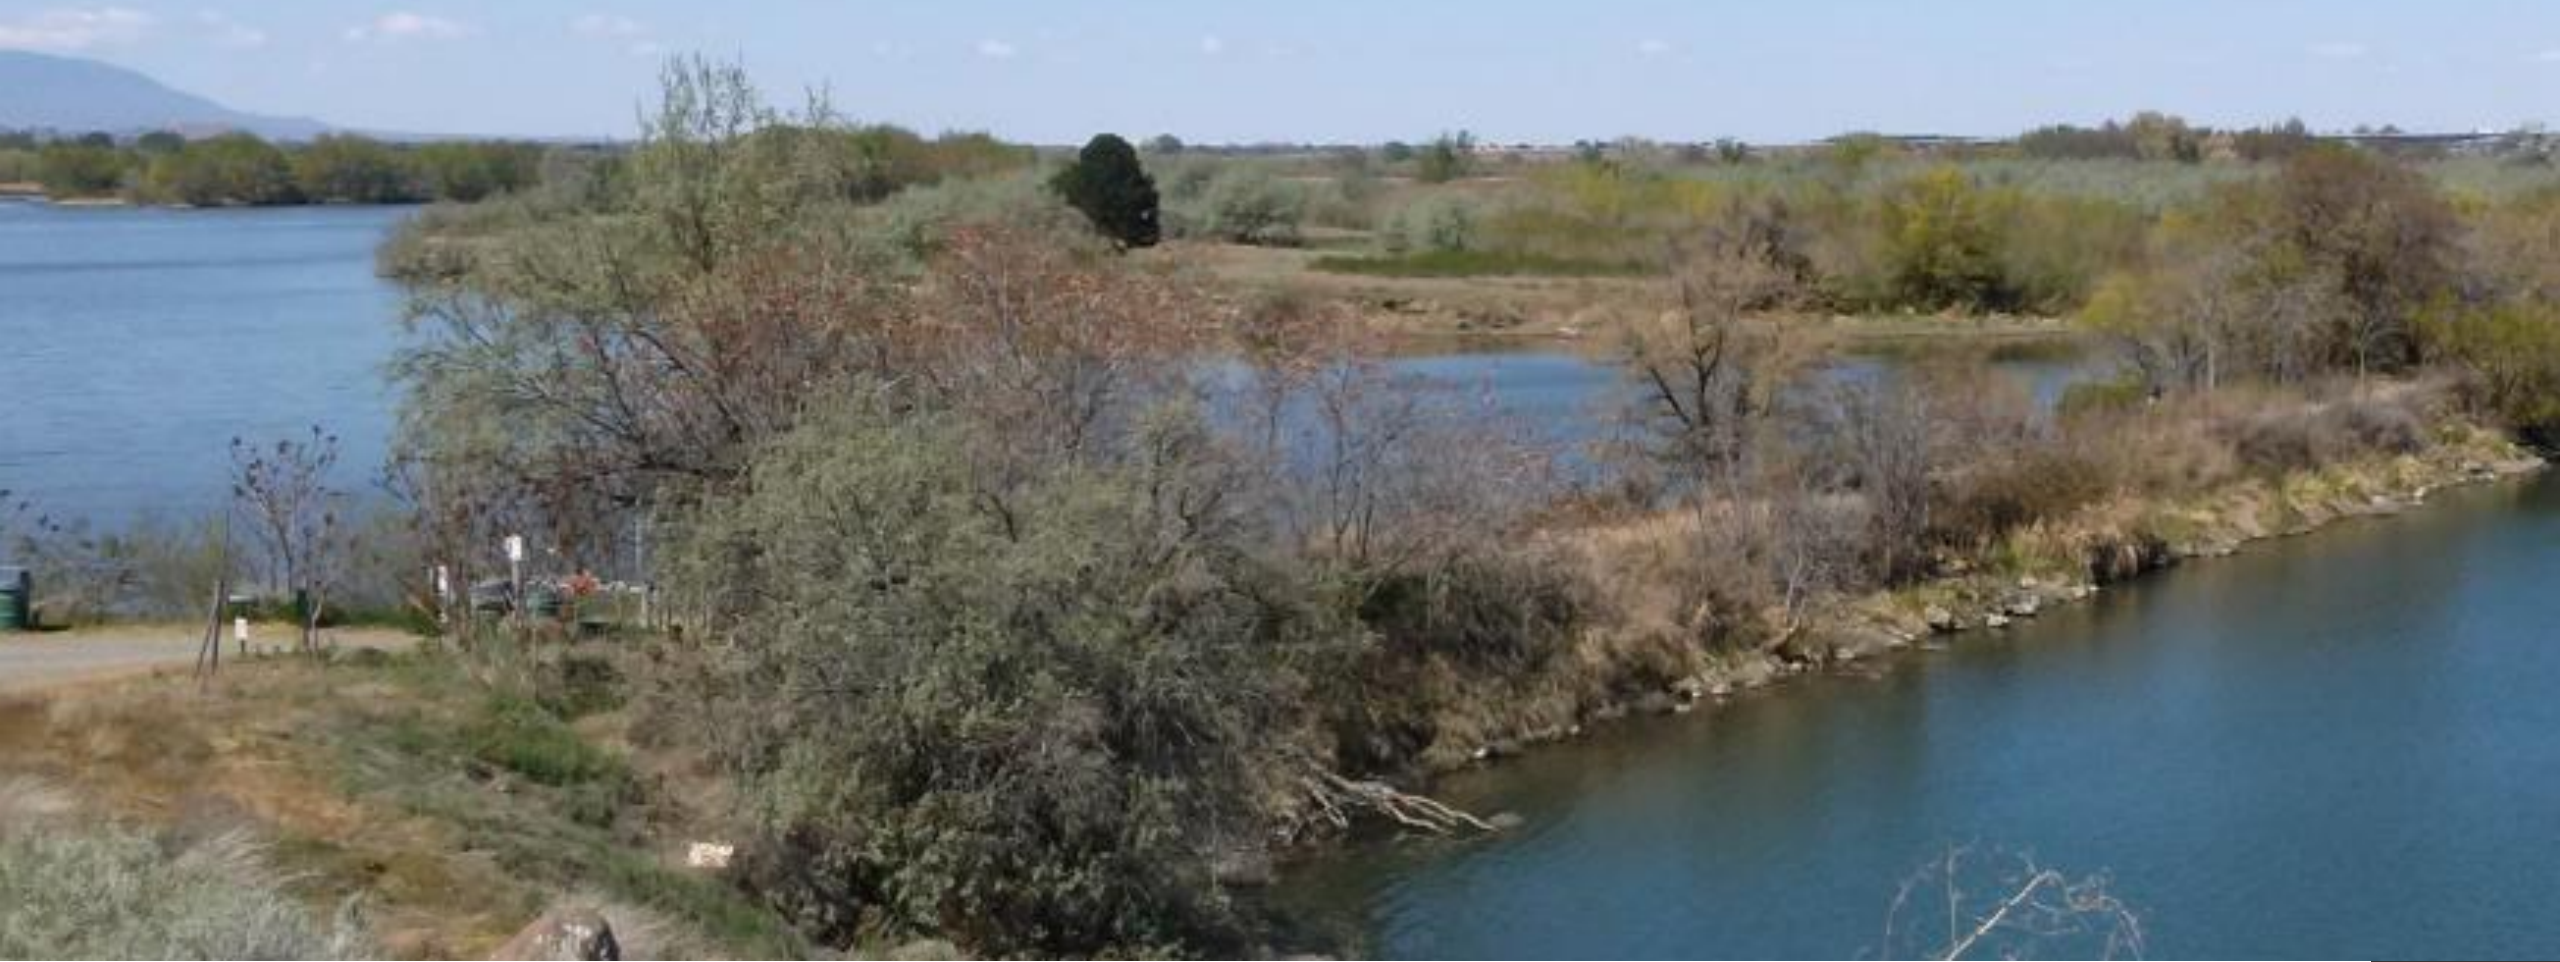
● When Yakima > 3000 cfs ● When Yakima < 3000 cfs

Percent of Total Flow Volume at Causeway Channel by Source (March through October)				
Alternative	Yakima River Inflows		Columbia River Inflows	
	2012	2014	2012	2014
6 - 130' Breach	100%	99%	0%	1%
7 - 200' Breach	95%	93%	5%	7%
5 - 260' Breach	76%	83%	24%	17%
3 - Full Breach	72%	81%	28%	19%
8 – Full breach + Breakwater	75%	80%	25%	20%
